Bolton Council

# **Bolton Town Centre**

## River Defence Inspection

October 2009

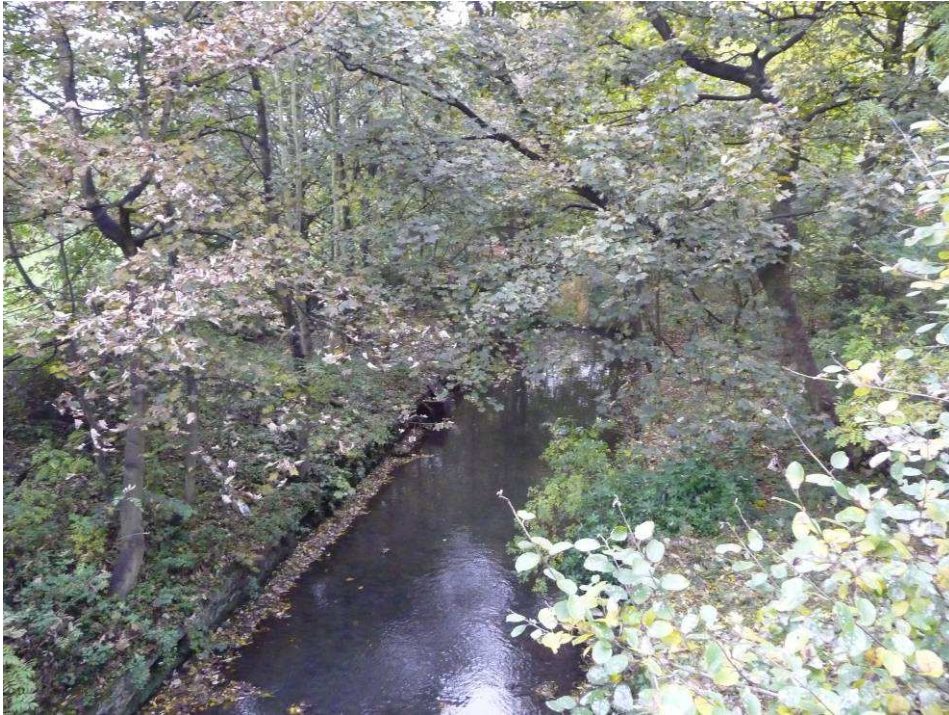
Plate 1 – View downstream from Mayor Street Bridge

Chainage	Classification	Notes	Plate No's
<i>General Notes</i> Approximately 80% of section investigated from both banks and various footbridges Stone pitching to base of channel, flat bottom apart from stretch between CH430 – CH495 which has a distinct dry weather flow channel.			
Right bank			
0 – 225	Masonry lined channel	Stone lined channel, good condition	1 – 3
225 – 435	Natural – channel – heavily vegetated	Densely vegetated channel No sign of instability due to erosion at base of bank or oversteep banks	4
435 – 640	Masonry lined channel	Stone lined channel, good condition	5 – 8
Left bank			
0 – 225	Masonry lined channel	Stone lined channel, reasonable condition	1 – 3
225 – 435	Natural – channel – heavily vegetated	Densely vegetated channel No sign of instability due to erosion at base of bank or oversteep banks	4
435 – 640	Masonry lined channel	Stone lined channel, good condition	5 – 8

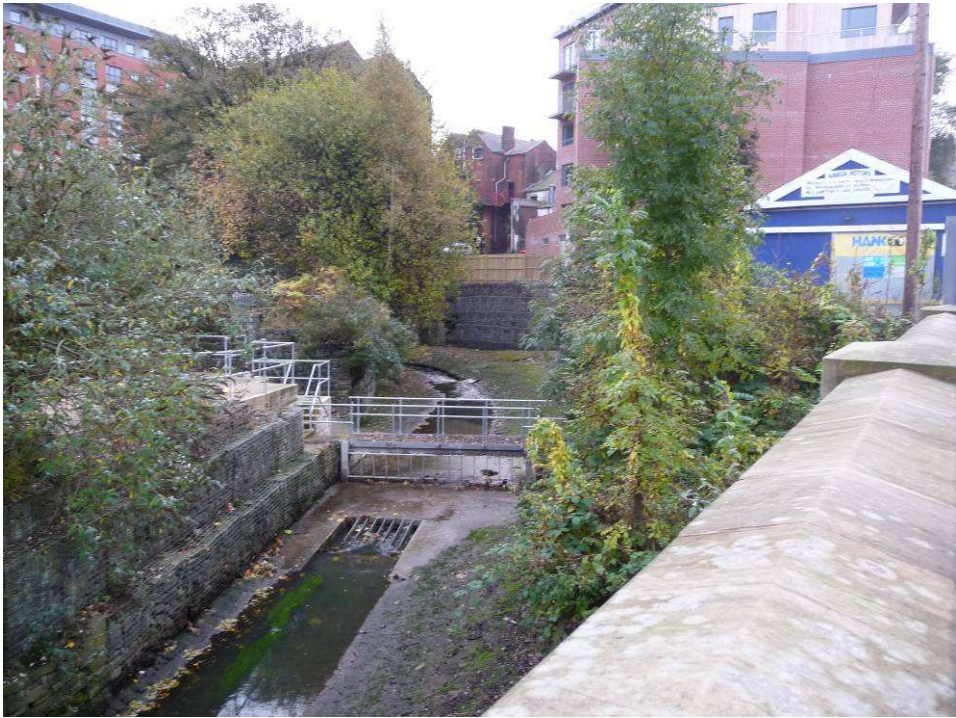
Plate 9 - - View downstream from Chorley Street bridge

Chainage	Classification	Notes	Plate No's
<i>General Notes</i> 100% of section investigated from left bank Stone pitching to base of channel with distinct dry weather flow channel			
Right bank			
640 – 720	Masonry lined channel	Stone lined channel, good condition	9
Left bank			
640 – 720	Masonry lined channel	Stone lined channel, good condition	9

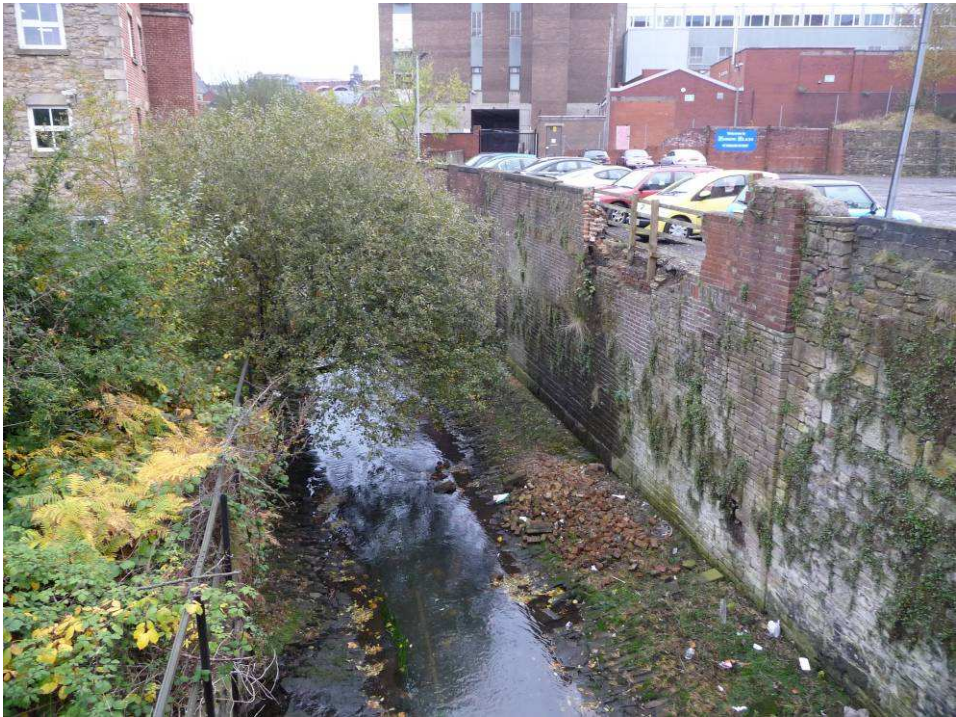
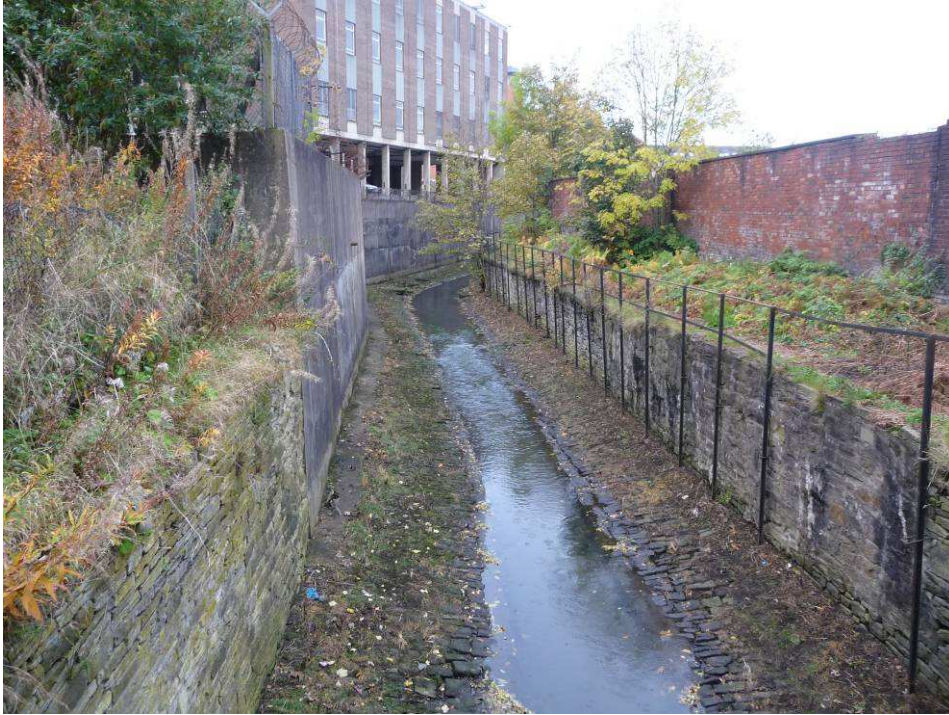
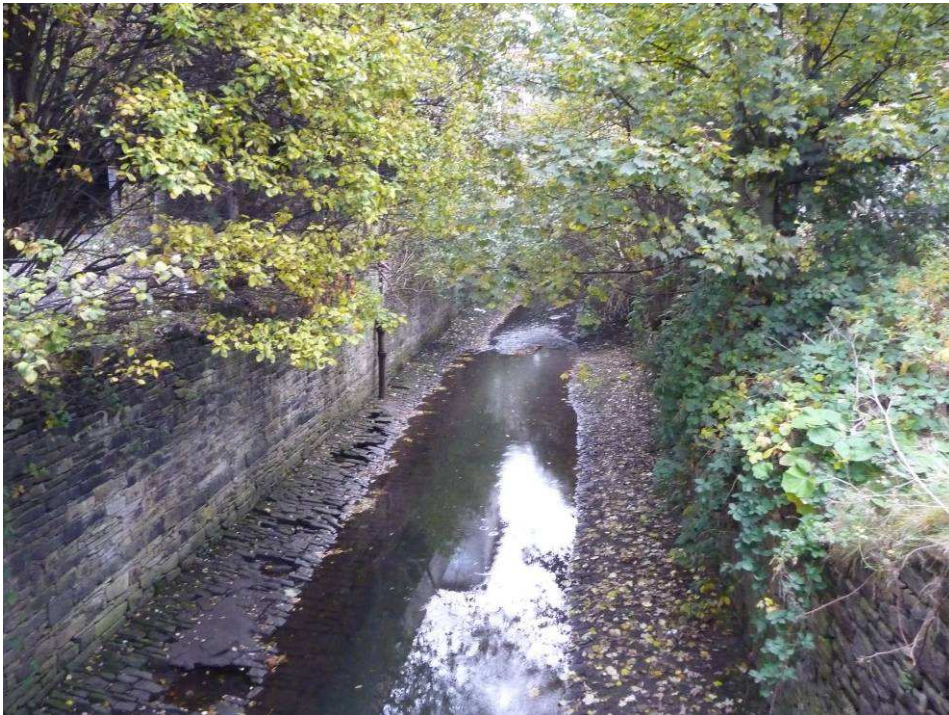
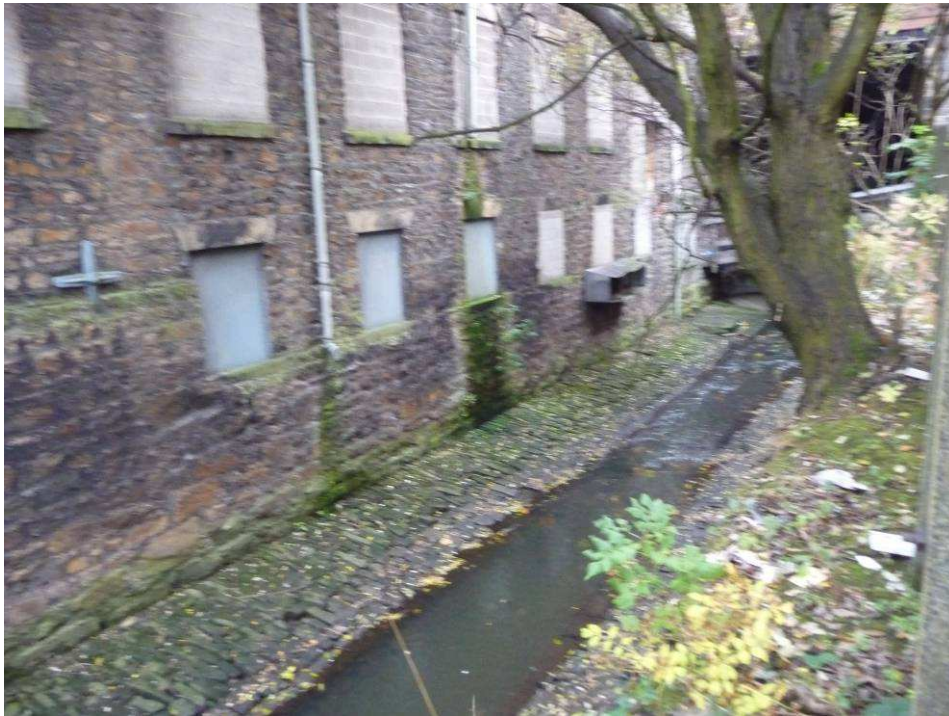
Chainage	Classification	Notes	Plate No's
<i>General Notes</i> <i>100% of section investigated from left bank</i> <i>Stone pitching to base of channel with distinct dry weather flow channel.</i>			
Right bank			
825 – 1050	Masonry lined channel	Stone lined channel, good condition up to 4m in height	10 – 13
Left bank			
825 – 1050	Masonry lined channel	Stone lined channel, good condition up to 4m in height	10 – 13

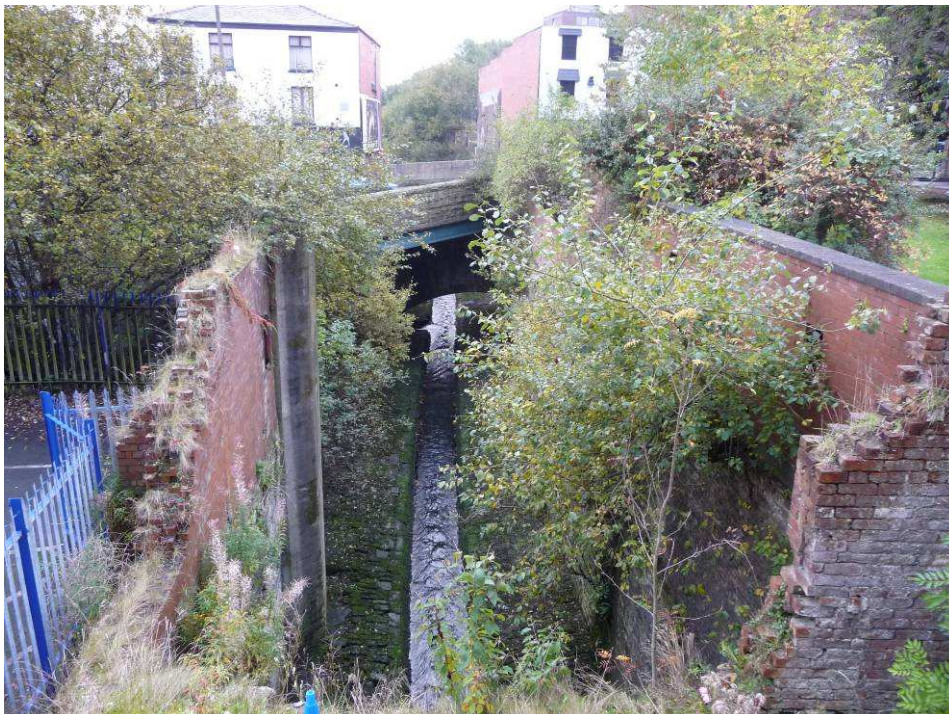
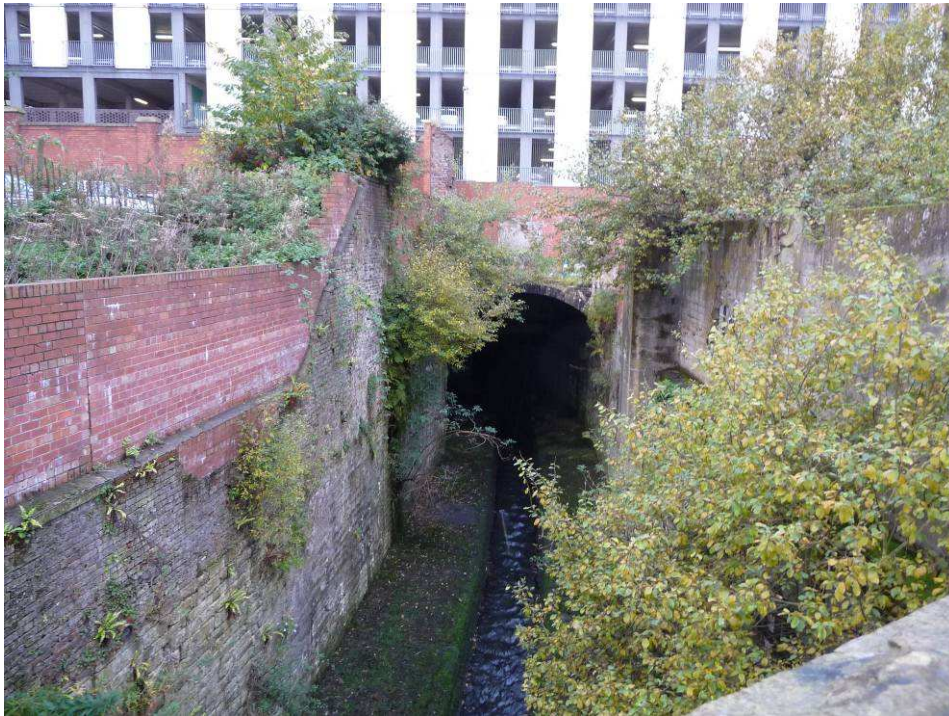
Chainage	Classification	Notes	Plate No's
<i>General Notes</i> 100% of section investigated from bridges on Manor Street and Crown Street Stone pitching to base of channel with distinct dry weather flow channel			
Right bank			
1360 – 1405	Masonry lined channel	Stone lined channel, good condition	14, 15
Left bank			
1360 – 1405	Masonry lined channel	Stone lined channel, good condition	14, 15

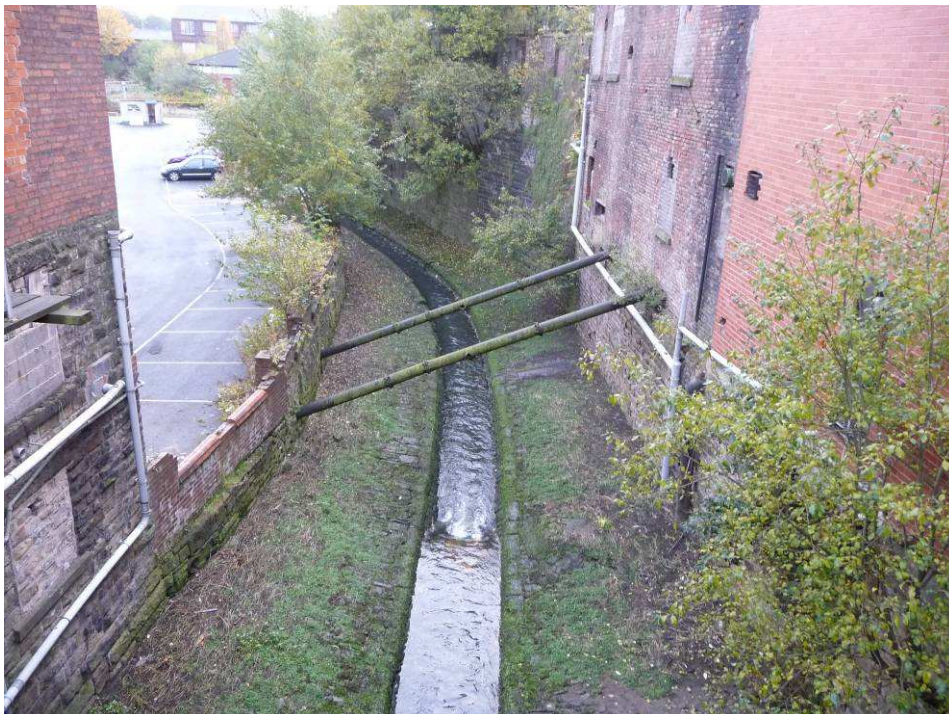
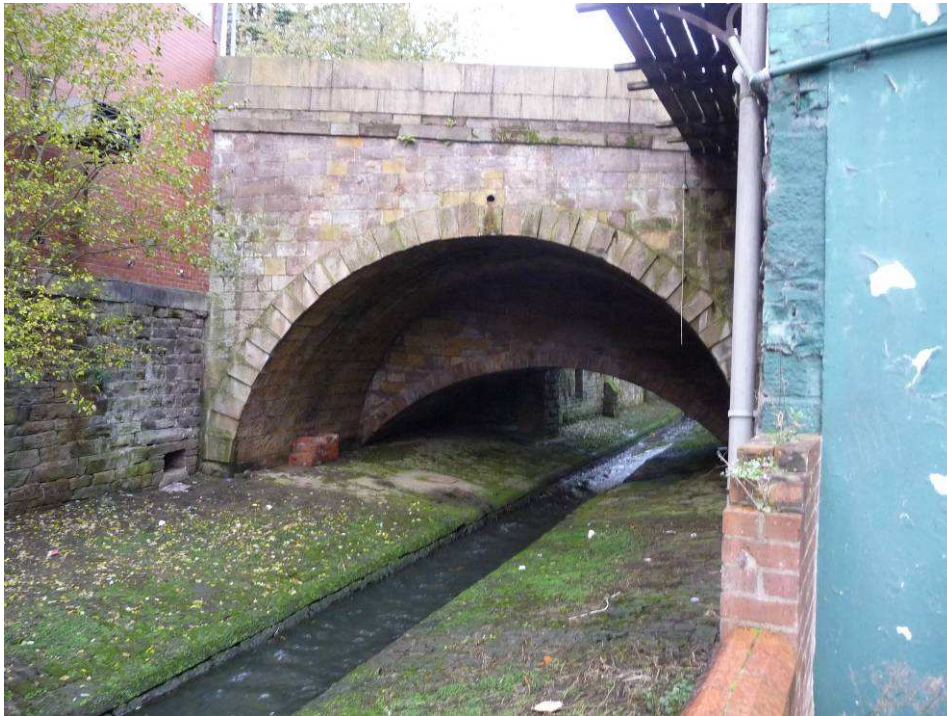
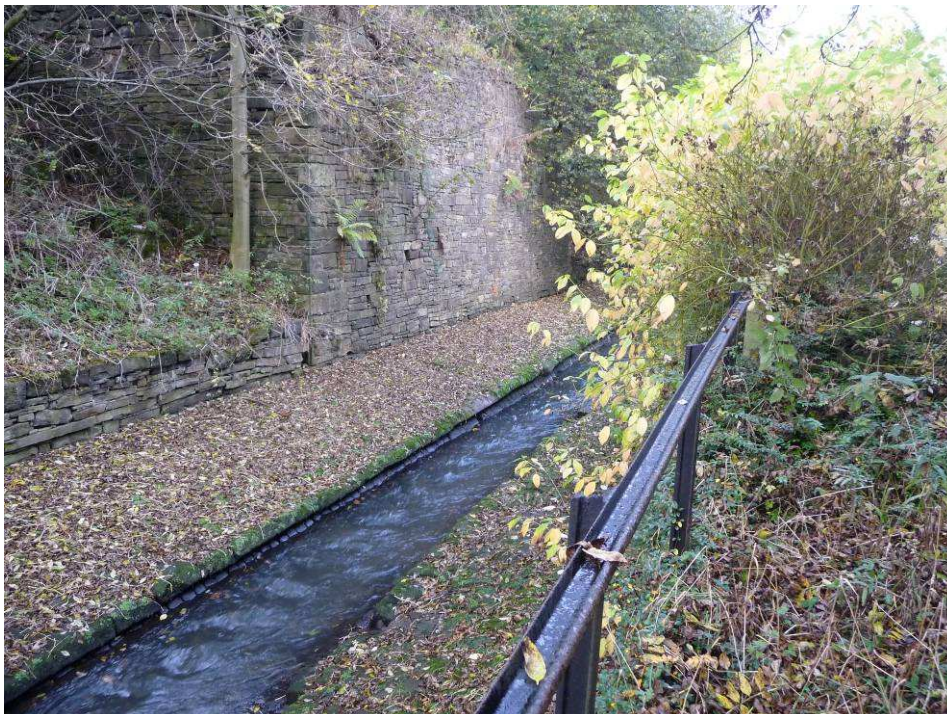
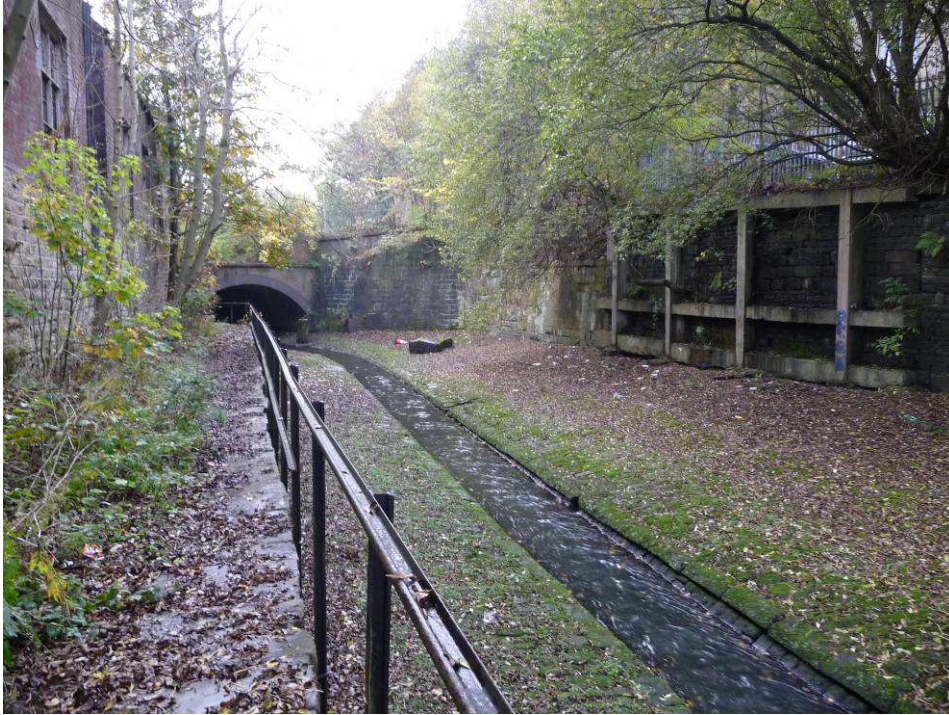
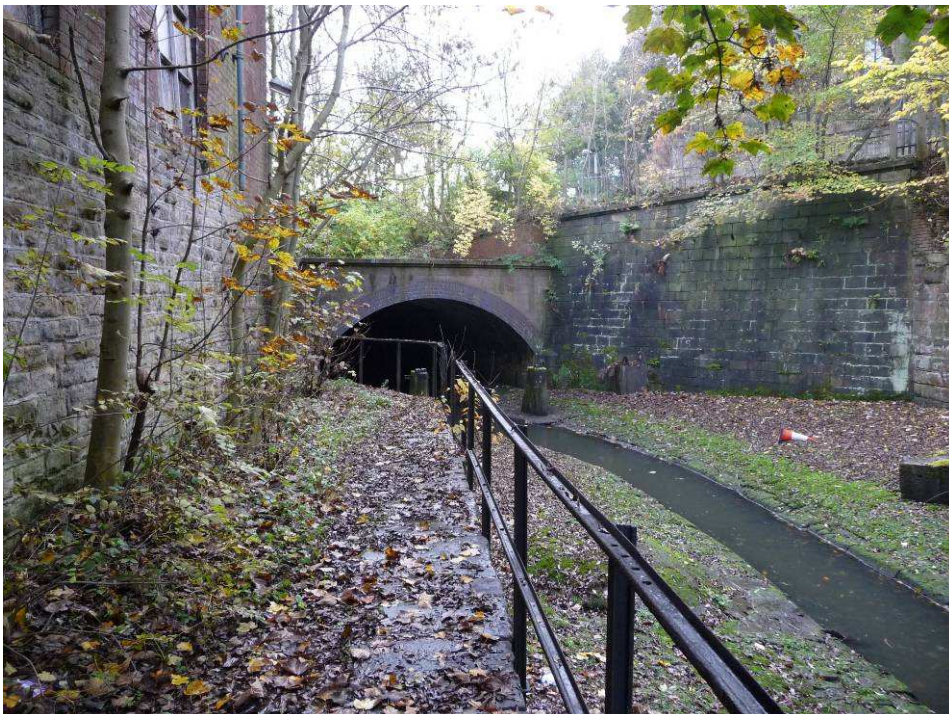
Chainage	Classification	Notes	Plate No's
<i>General Notes</i> 100% of section investigated from left bank Stone pitching to base of channel with distinct dry weather flow channel			
Right bank			
1405 – 1615	Masonry lined channel	Stone lined channel, good condition	16 – 20
Left bank			
1405 – 1615	Masonry lined channel	Stone lined channel, good condition	16 – 20
